Re: Notice of Violation Compliance Evaluation Inspection ILD 045 304 367

#### COMPLIANCE EVALUATION INSPECTION REPORT

INSTALLATION NAME: Chicago Tribune - Freedom Center

#### Attachment 1 Chicago Tribune- Freedom Center RCRA ID: ILD 045 304 367 July 16, 2014

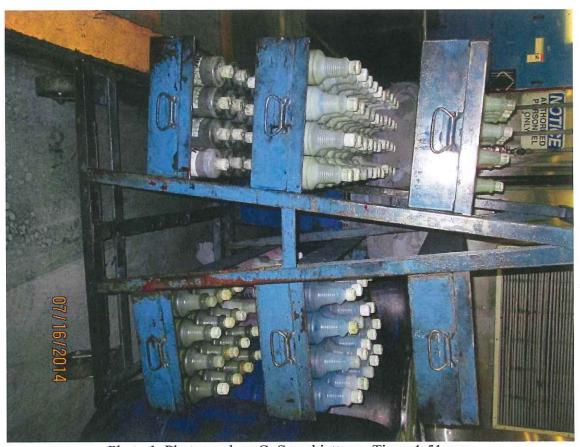
Photo 1. Photographer: G. Scambiatterra. Time: 1:51 p.m. Description: Blanket wash mix to be used to clean the press blankets full of ink.

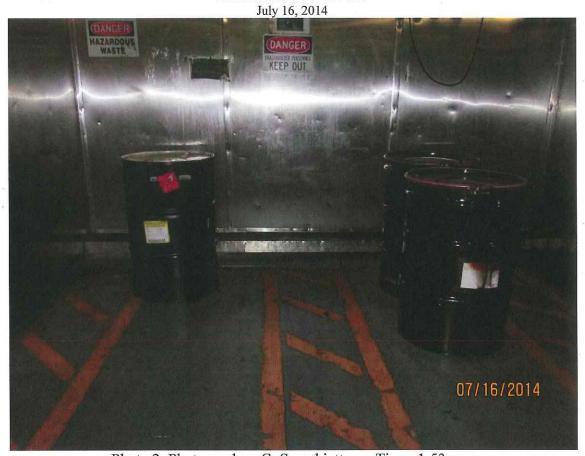
At the time of the inspection, the Tribune was accumulating one container of hazardous waste without the accumulation start date.

The next area we inspected was the Ink Cleanup Room. Here, the flammable blanket wash chemical gets mixed with water for each press area. Blanket wash chemical arrives at the Tribune in 330-gallon totes and is stored in this area until needed. When the blanket wash chemical gets mixed, it's placed in hand-held containers to be used in the press area (see photo 1). Buckets are used to capture the rinses and they are re-used several times on the press machines until the blanket wash rinses become a hazardous waste. Once this determination is made, the buckets of hazardous waste are taken to the less than 90-day storage area and placed in 55-gallon containers. The less than 90-day storage area was also located in this area. We walked over to the storage area and I observed three 55-gallon containers in the area (see photo 2). The container on the left was the only one containing hazardous blanket wash waste and was labeled with the words "waste print ink related material." I took a closer look at the Hazardous Waste label and noted that it did not have the accumulation start date written anywhere on the label. I checked the rest of the container and did not see the accumulation start date anywhere else on the container. I pointed this out to Mr. Ford and Ms. Powell.

- 4. Hazardous Waste: we discussed the missing accumulation start date on the 55-gallon container of hazardous blanket wash waste/waste print ink related material.

Photo 2. Photographer: G. Scambiatterra. Time: 1:53 p.m.

Description: Blanket wash waste/waste print ink related material (left container).

Container did not have an accumulation start date. Right containers are non-hazardous waste.

At this time, EPA is not requiring the Tribune to apply for an Illinois hazardous waste storage permit so long as it immediately establishes compliance with the conditions for a permit exemption outlined in paragraphs 1-2, above.

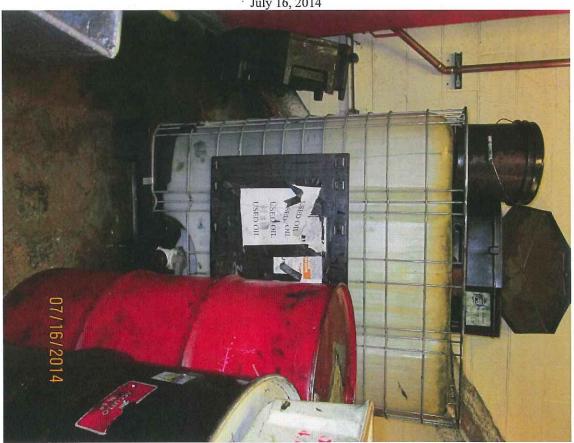
Photo 3. Photographer: G. Scambiatterra. Time: 2:00 p.m. Description: Used oil tote – half full.
